ARCHITECTURAL

FACILITY ASSESSMENT

Administration Building

For Wasatch County
Project No. 22170

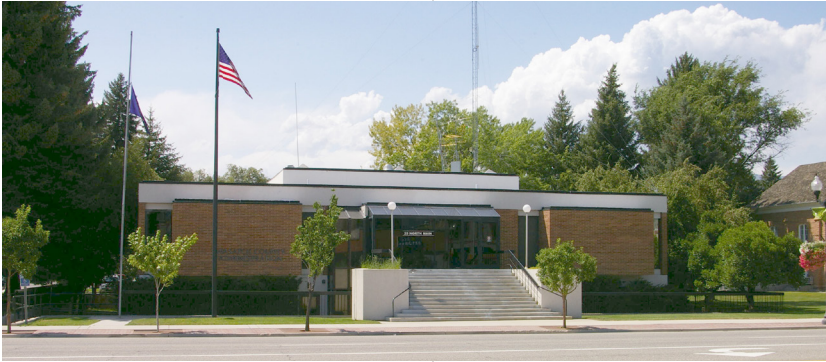
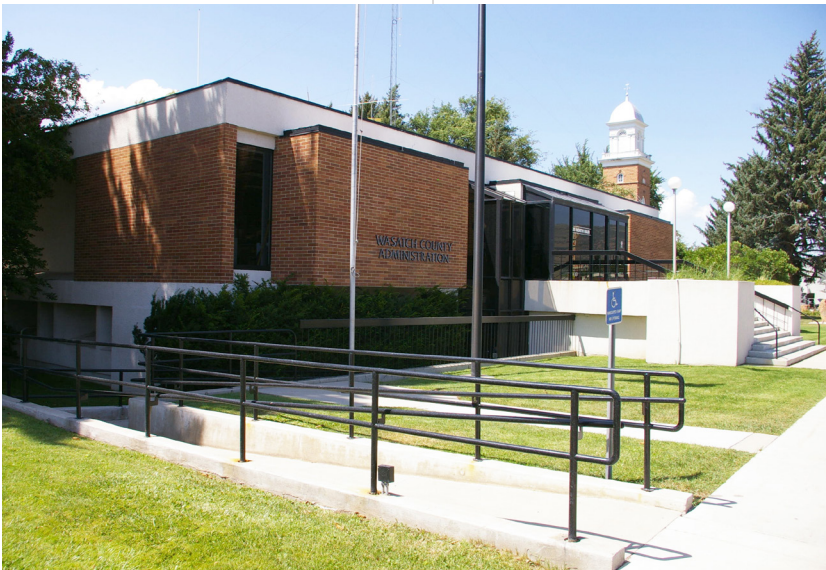
Exterior images illustrate building materials, entry stairs, and ADA access ramp down to lower level at entry.

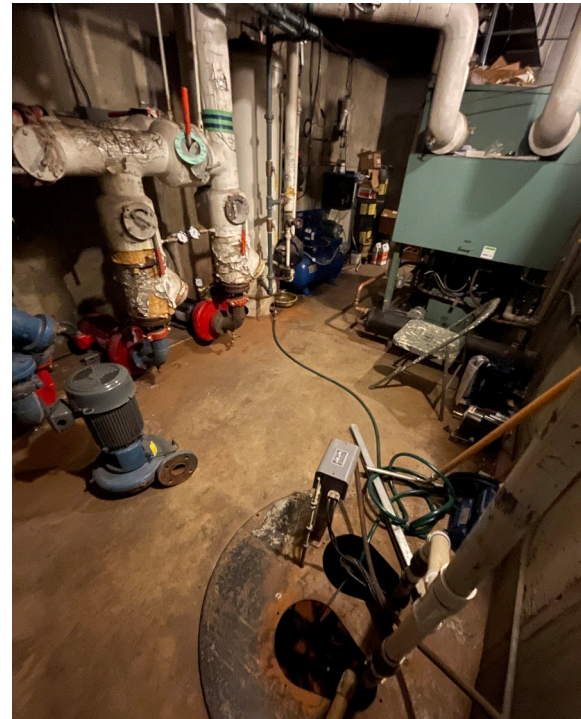
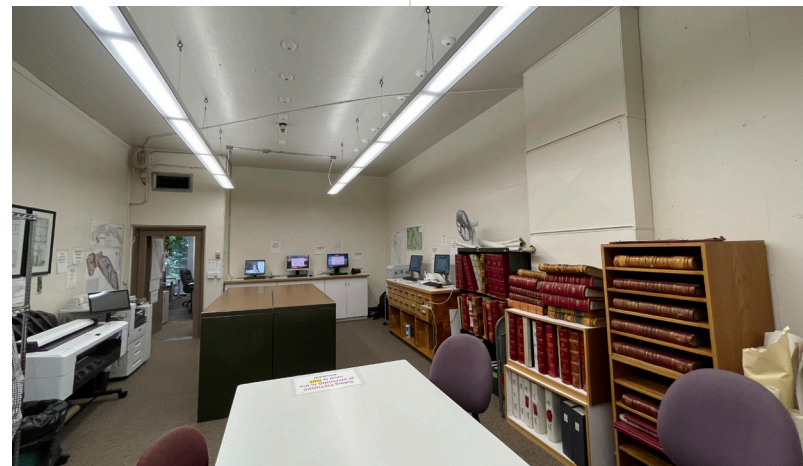
Aged building mechanical systems are shown to the left and the "bunker-like" atmosphere of some interior spaces is illustrated below.

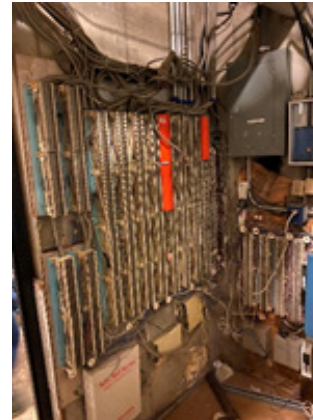
Grounding and bonding of the telecommunications equipment does not seem to be present. Proper grounding and bonding of communication systems provide reliable operation for voice/data equipment, while enhancing safety for the personnel. Further investigation should be done to confirm the existence, resistance readings, and condition of the telecommunication grounding and bonding systems

Telecom service blocks

- Upgrade the existing grounding system as required and remove all grounding conductors that do not comply with the NEC code.
- Replace non-GFCI outlets with GFCI outlets in all locations specified in NEC 210.8 (B).
- Provide battery packs for egress lighting and exit signs as needed to comply with the IBC code egress lighting requirements.
- Recommend providing a complete fire alarm system for the entire building
- Relocate all the existing Telecommunication cables that are run inside mechanical ducts.

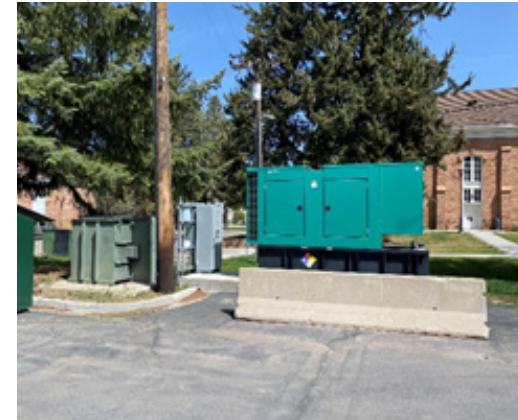
There is an existing generator and a single ATS which backs up the entire building.

Generator and ATS

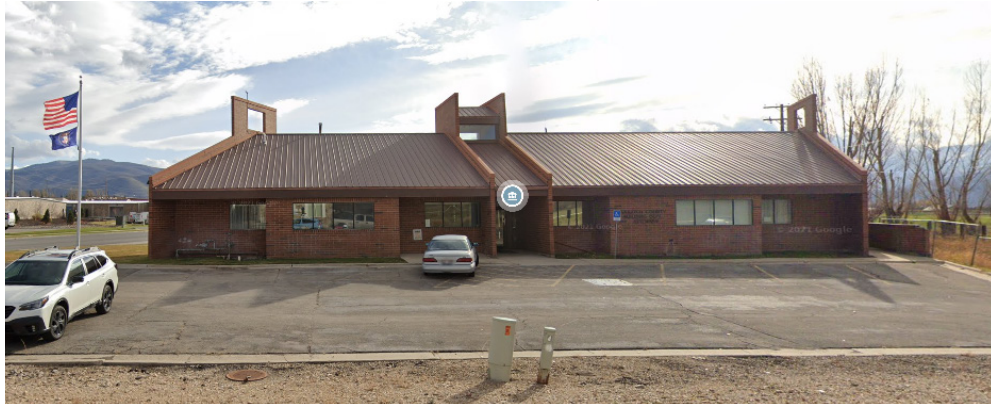
The Wasatch County Attorney's Building was constructed in 1984. The building is a single story, masonry building with a pitched, standing-seam metal roof. The building was constructed with a masonry bearing wall structure, and sits just to the east of the Sagebrush and Spring Creek Canal. The proximity to the canal, and the lack of structural stabilization on the west side of the building has resulted in visible settling of the building and cracks in the bearing walls.

The exterior images illustrate the materials, water damage, and settling experience over time by the building.

We recommend repairing the building settlement soon by shoring up the west side building foundations. Next time the building is re-roofed, we recommend creating positive seismic connections between the wood roof and masonry walls.

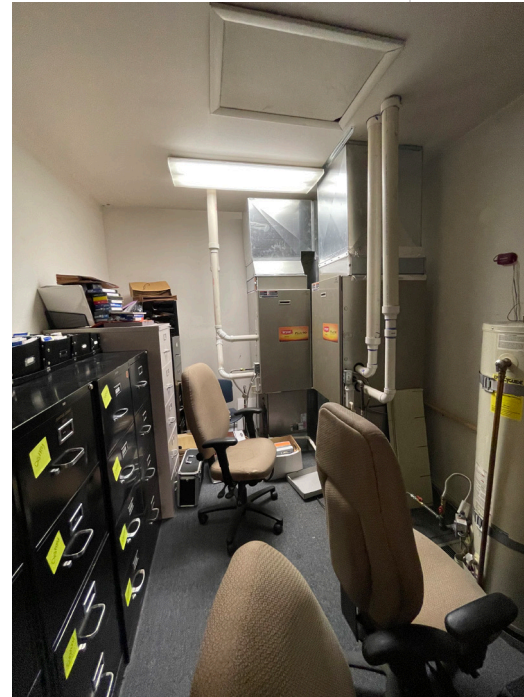
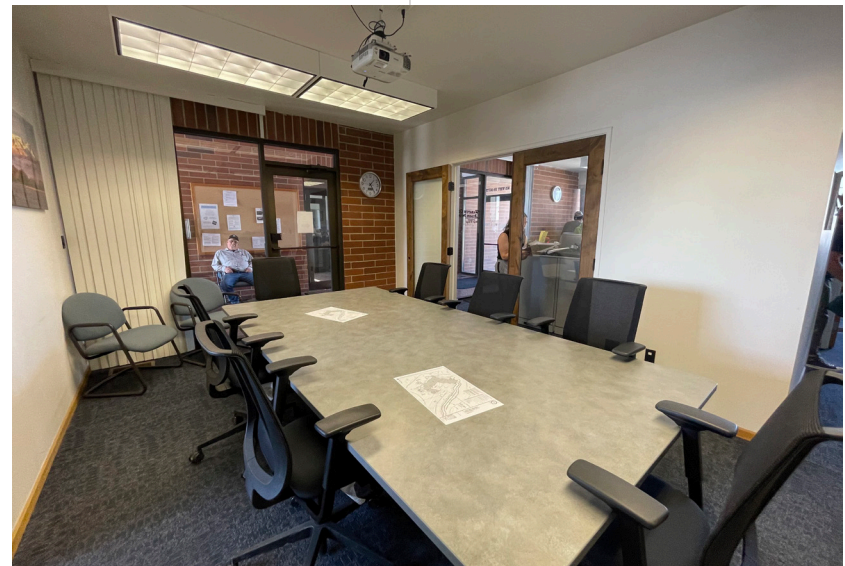
The interior spaces have been renovated over time to meet the needs of the City. Existing lighting and systems could be updated for efficiency.

Existing lighting controls largely consist of toggle switches. Significant upgrades to the interior lighting control systems are needed to meet the latest energy code. There are opportunities for energy savings by installing lighting controls such as occupancy sensors and timed relay controls.

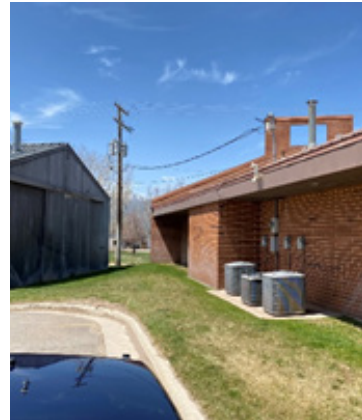
Overhead utility transformer connection at the rear of the building.

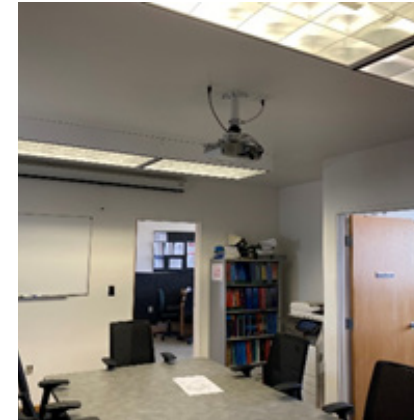
Majority of the building has older florescent T8 surface troffers. These light sources are outdated and very inefficient. All existing light fixtures are recommended to be replaced with new LED lighting.

T8 Troffers and older technology systems can be seen in the image above.

- Upgrade the existing grounding system as required and remove all grounding conductors that do not comply with the NEC code.
- Replace non-GFCI outlets with GFCI outlets in all locations specified in NEC 210.8 (B).
- Provide battery packs for egress lighting and exit signs as needed to comply with the IBC code egress lighting requirements.
- Recommend providing a complete fire alarm system for the entire building
- Consider backup power for emergency and egress lighting and optional standby backup power for telecommunication loads and air-conditioning.

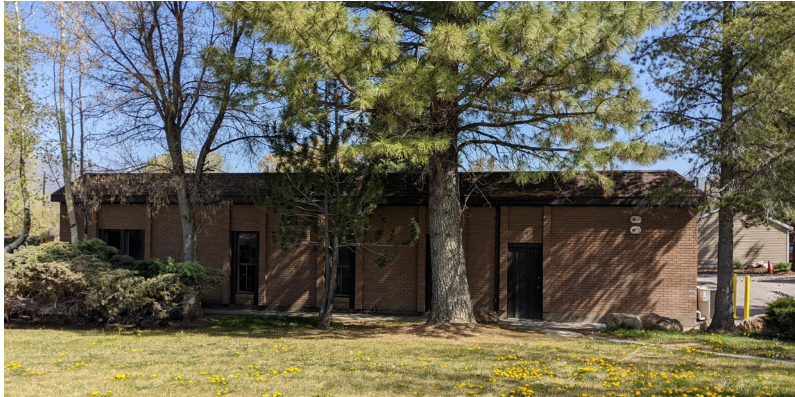
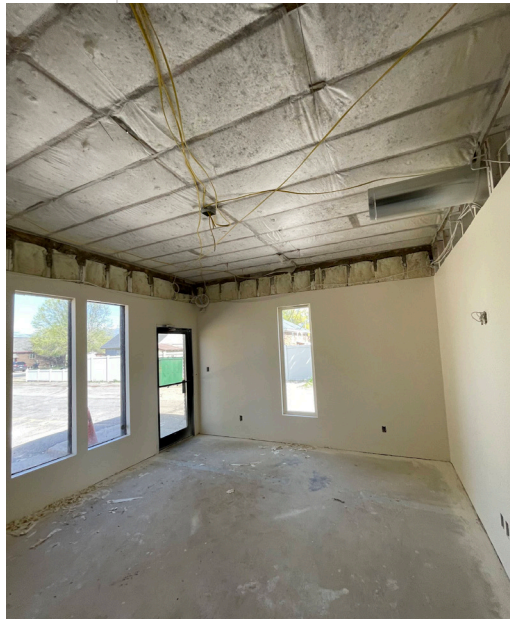
The exterior was kept largely intact with new windows provided, and the interior was fully renovated.

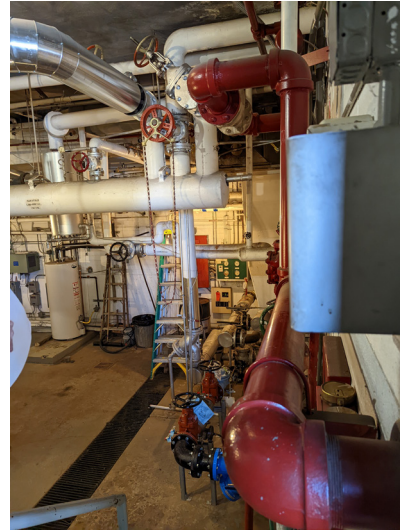
Aged building systems, finishes, and technology systems can be seen in the images on this page.

- Replace all existing Square D electrical distribution panels, panelboards and motor control centers.
- A full evaluation and inspection of fuel storage tank for the generator is recommended
- Provide detailed evaluation of the existing grounding system.
- Upgrade the existing grounding system as required and remove all grounding conductors that do not comply with the NEC code.
- Replace non-GFCI outlets with GFCI outlets in all locations specified in NEC 210.8 (B).
- Provide battery packs for egress lighting and exit signs as needed to comply with the IBC code egress lighting requirements.
- Recommend providing a complete working fire alarm system for the entire building.

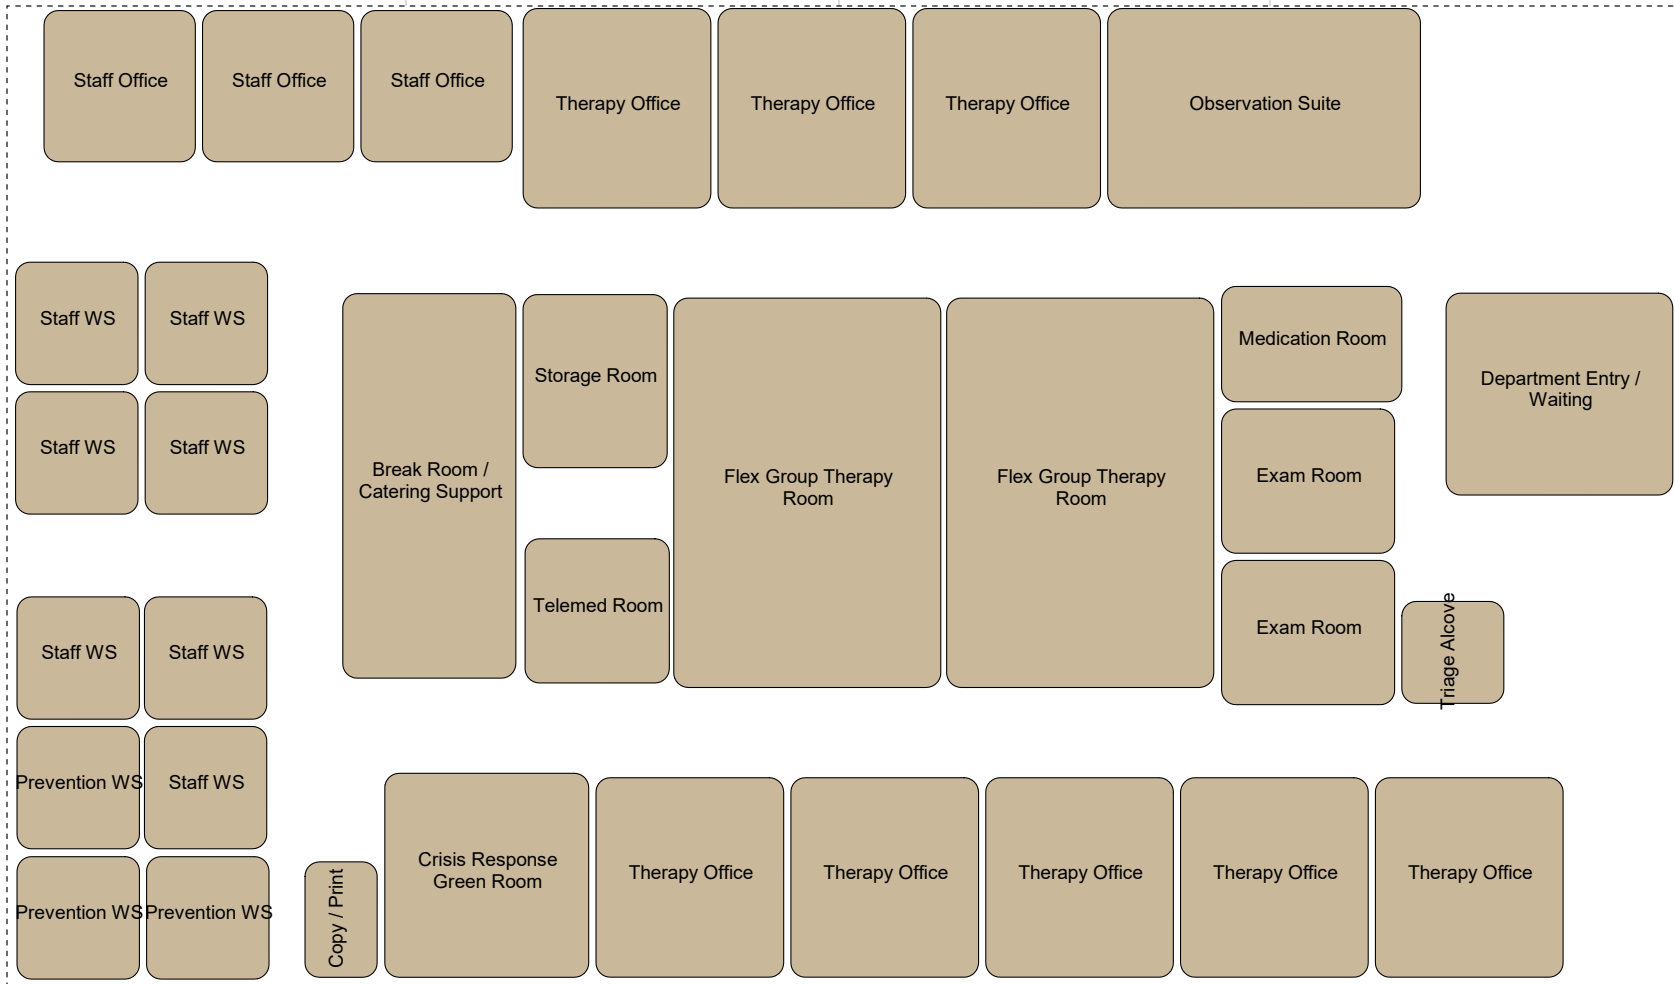
Wasatch Behavioral Health Adjacency Diagram

SPACE NAME	CAPACITY	SIZE	QUANTITY	TOTAL STAFF	NET AREA	NOTES
Therapy Office	1-4	180	8	8	1440	
Staff Office	1	120	3	3	360	2 Prescribers, 1 Nurse,
Prevention Workstation	1	72	3	3	216	Shared office with whiteboards
Staff Workstation	1	72	6	6	432	3 Peer Support, 1 Reception, 2 Interns
Copy / Print Alcove	-	40	1	-	40	
Triage Alcove	2	50	1	-	50	
Exam Room	2-4	120	2	-	240	Used by Nurse and Prescribers
Medication Room	-	100	1	-	100	
Flex Group Therapy Room	15-18	500	2	-	1000	Used as conference room as well
Observation Suite	varies	300	1	-	300	Includes play room and observation room
Telemedicine Room	1-2	100	1	1	100	
Crisis Response Green Room	1-2	200	1	2	200	Includes sleeping space and workspace
Break Room / Catering Support	8	320	1	-	320	Provide access to shared demonstration kitchen
Storage Room		120	1	-	120	Prevention staff + shared
Subtotal				23	4918

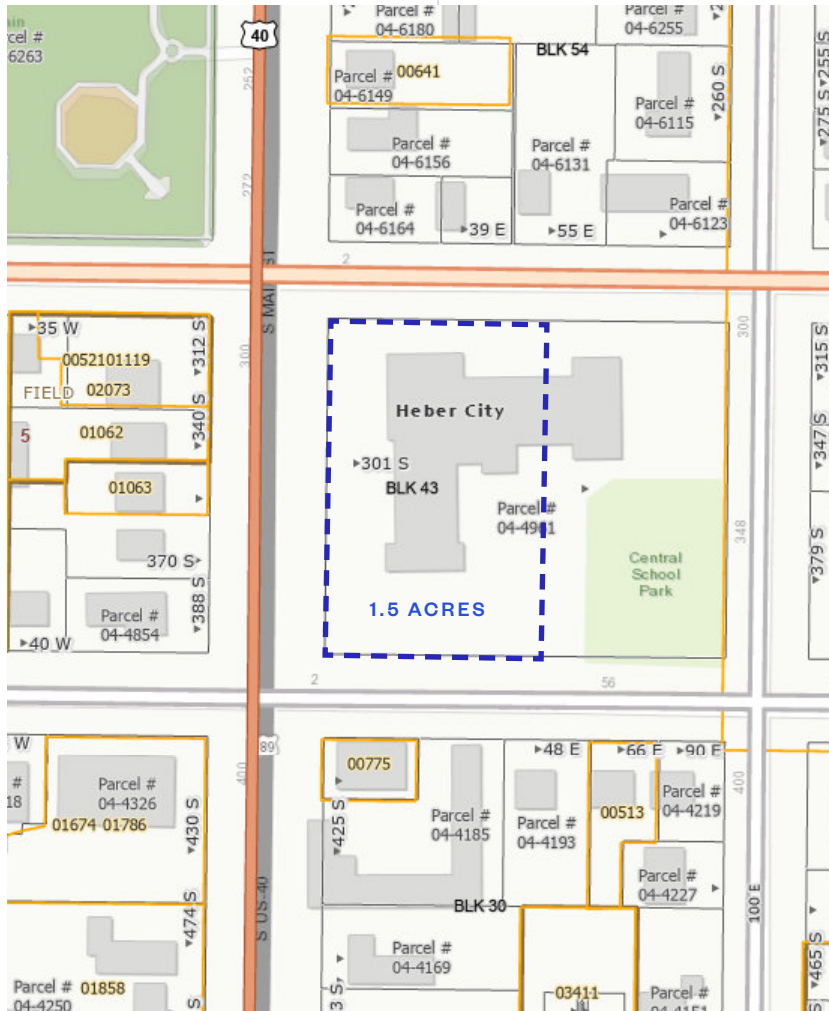
Heber Public Safety Building Site

The Heber City Public Safety Site includes 1.5 acres of land on the west half of the block south of 300 South, north of 400 South, west of Main Street.

A smaller civic facility is more appropriate for this site than either of the two new Wasatch county buildings recommended within this study.

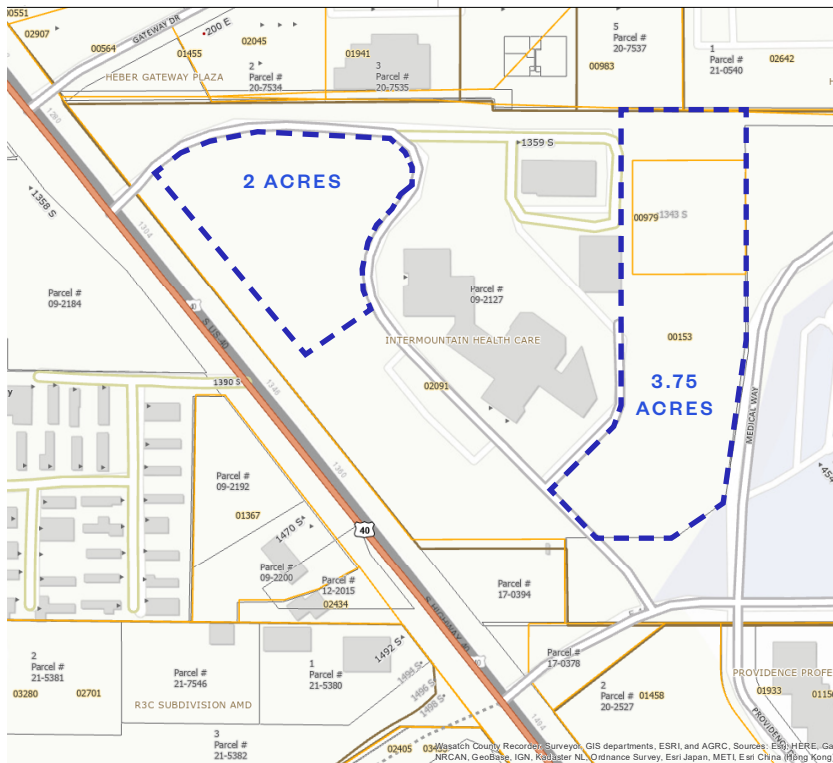
Wasatch Justice Facility Building Site

The Wasatch Justice Facility Site is located east of Highway 40, south of Gateway Drive and north of 1500 South. There are two potential buildable sites, a 2 acre site on the northwest corner of the site and a 3.75 acre site on the east side.

Based on a potential need for growth for the Justice Facility, including the holding areas, the Sheriff's Department office, and the courthouse, this site should be preserved to meet the long term-needs of the existing programs.

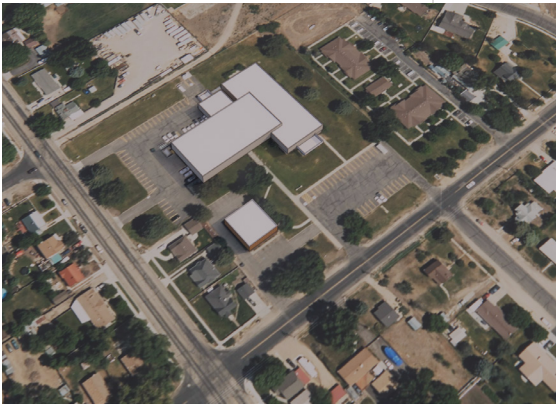
The site currently houses the Community Services and Central Operations buildings.

It is the recommendation of the study team that a new 2-story building be constructed at the west side of the site at the southeast corner of Center Street and east of 500 East.

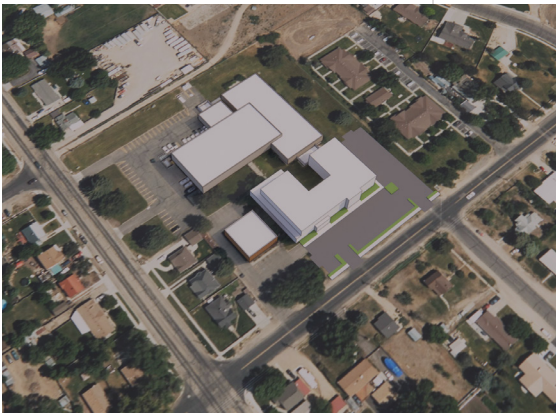
Phase 1 would include construction of a new Community Services Building on the west side of the site.

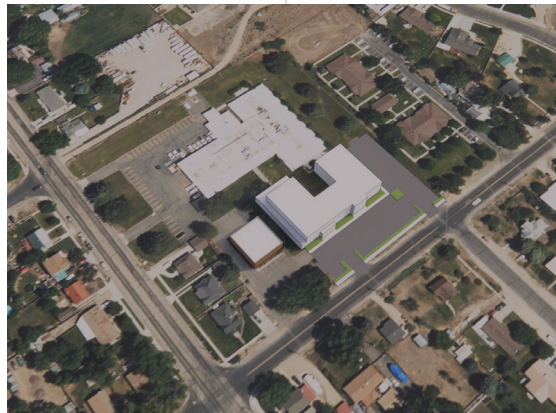
Phase 2 would be the demolition of the old Community Services Building.

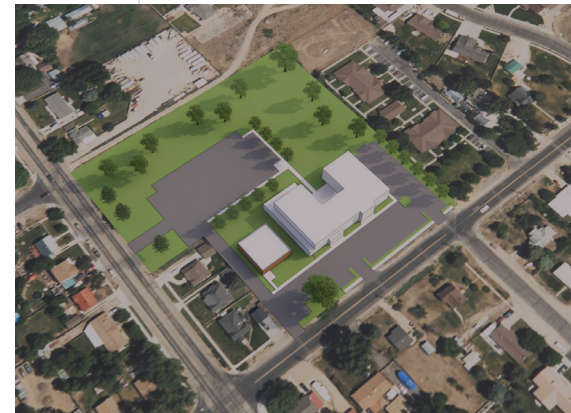
Phase 3 would be the completion of the site development to serve the new Community Services and existing Central Operations buildings.

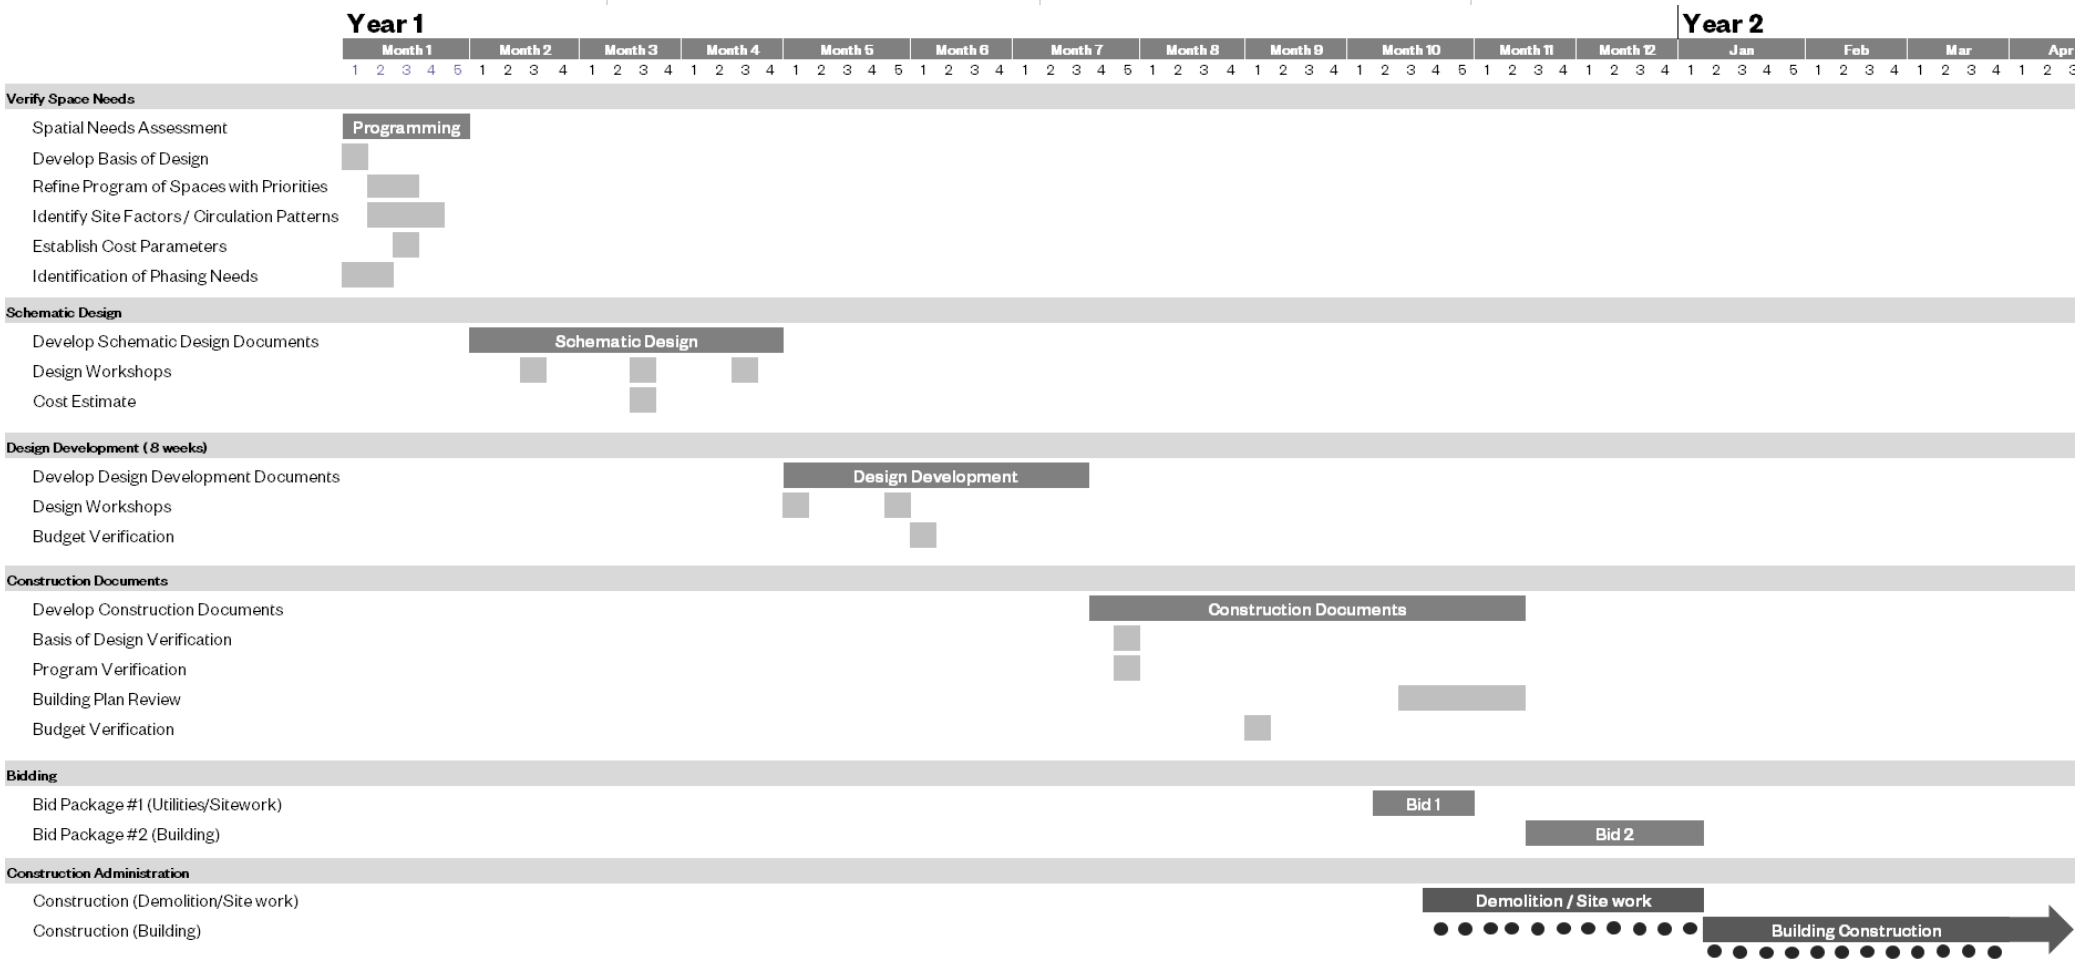
Project Schedule

A typical design schedule would be as follows based on the construction of a new building. With the two buildings, the construction could go in tandem, depending on the selected site(s) or in series, as preferred by the County.
